# *Jerome Landslide*

## *POTENTIAL CAUSES OF LANDSLIDE AND PROBABILISTIC APPROACH TO ASSESSING FUTURE RISK OF MOVEMENT*

*Scott D. Neely, P.E.  
Geotechnical Services Manager  
Terracon, Inc  
&  
ADOT Materials Group*

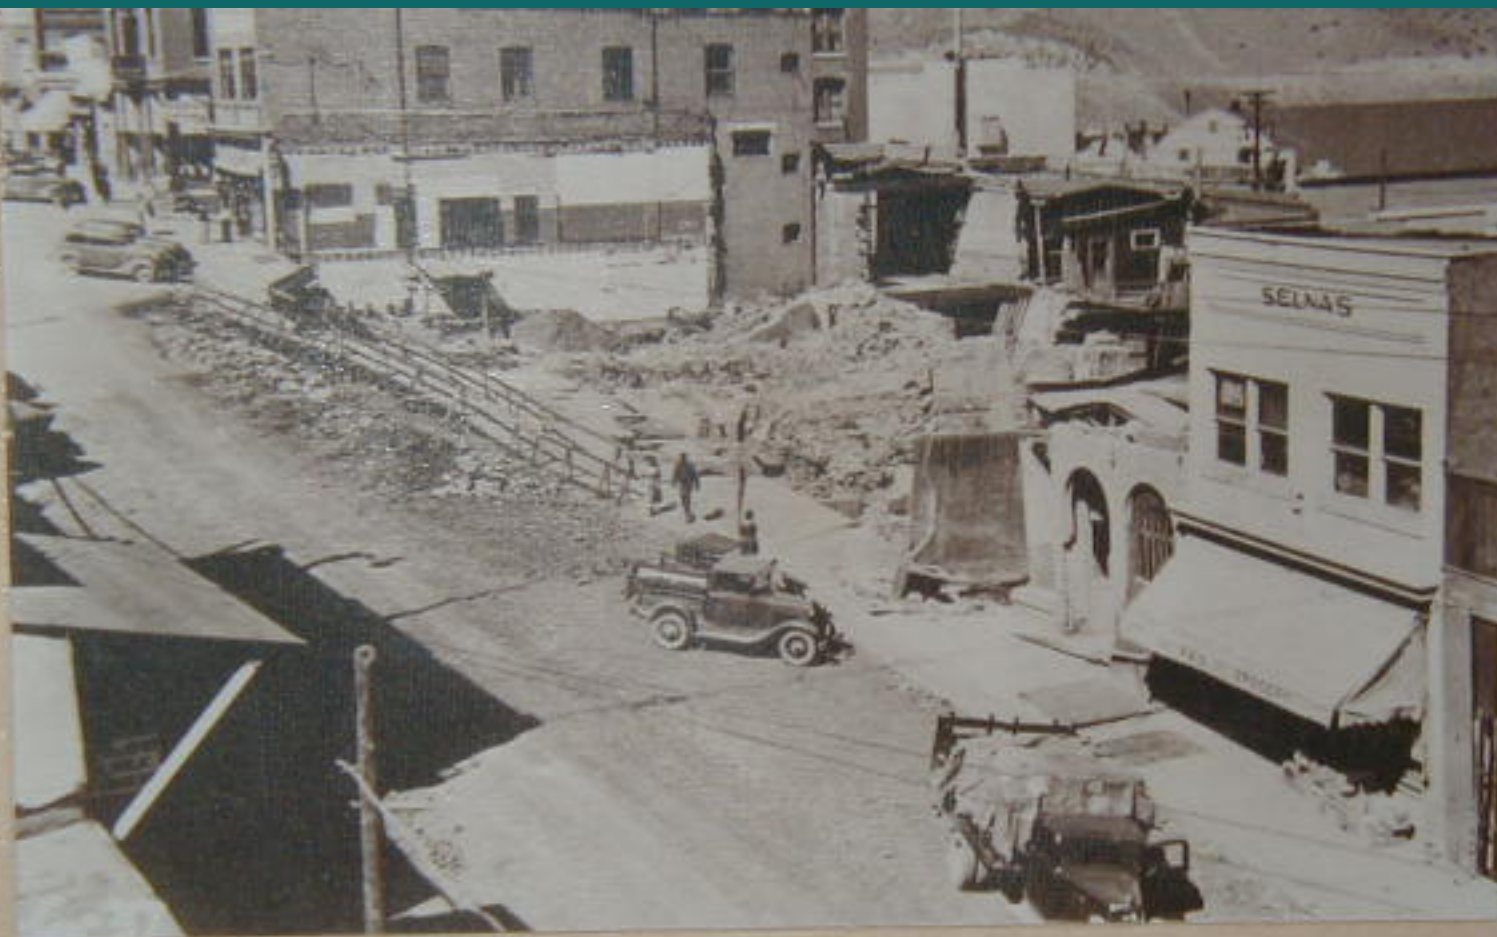
This lot once contained the second largest J.C. Penney store in the chain. As the store slipped away from the

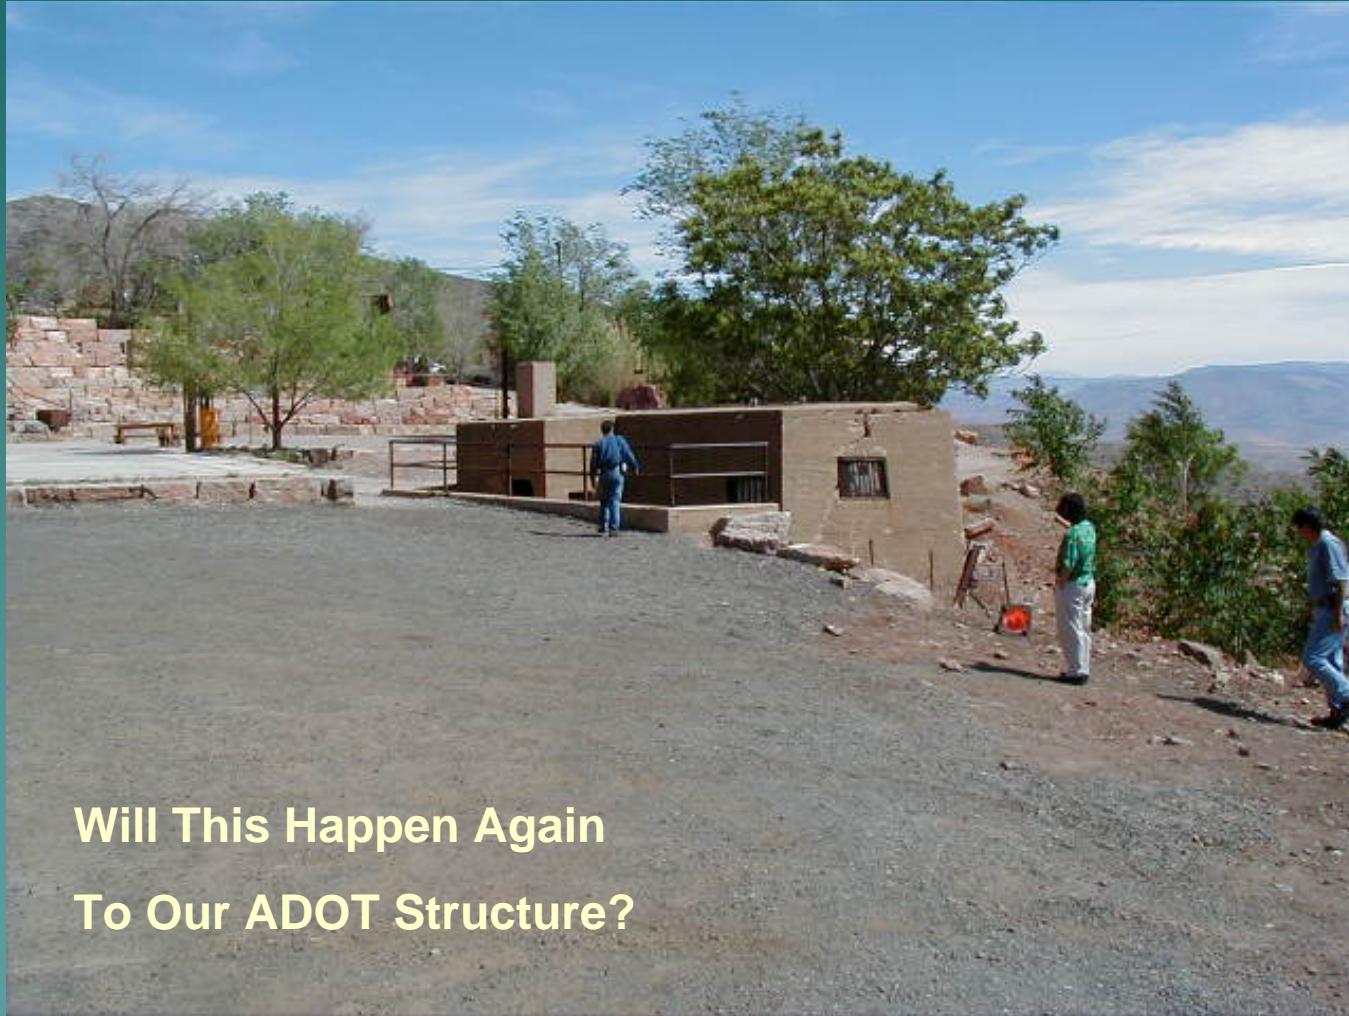
# Sliding Jail

Will This Happen Again  
To Our ADOT Structure?

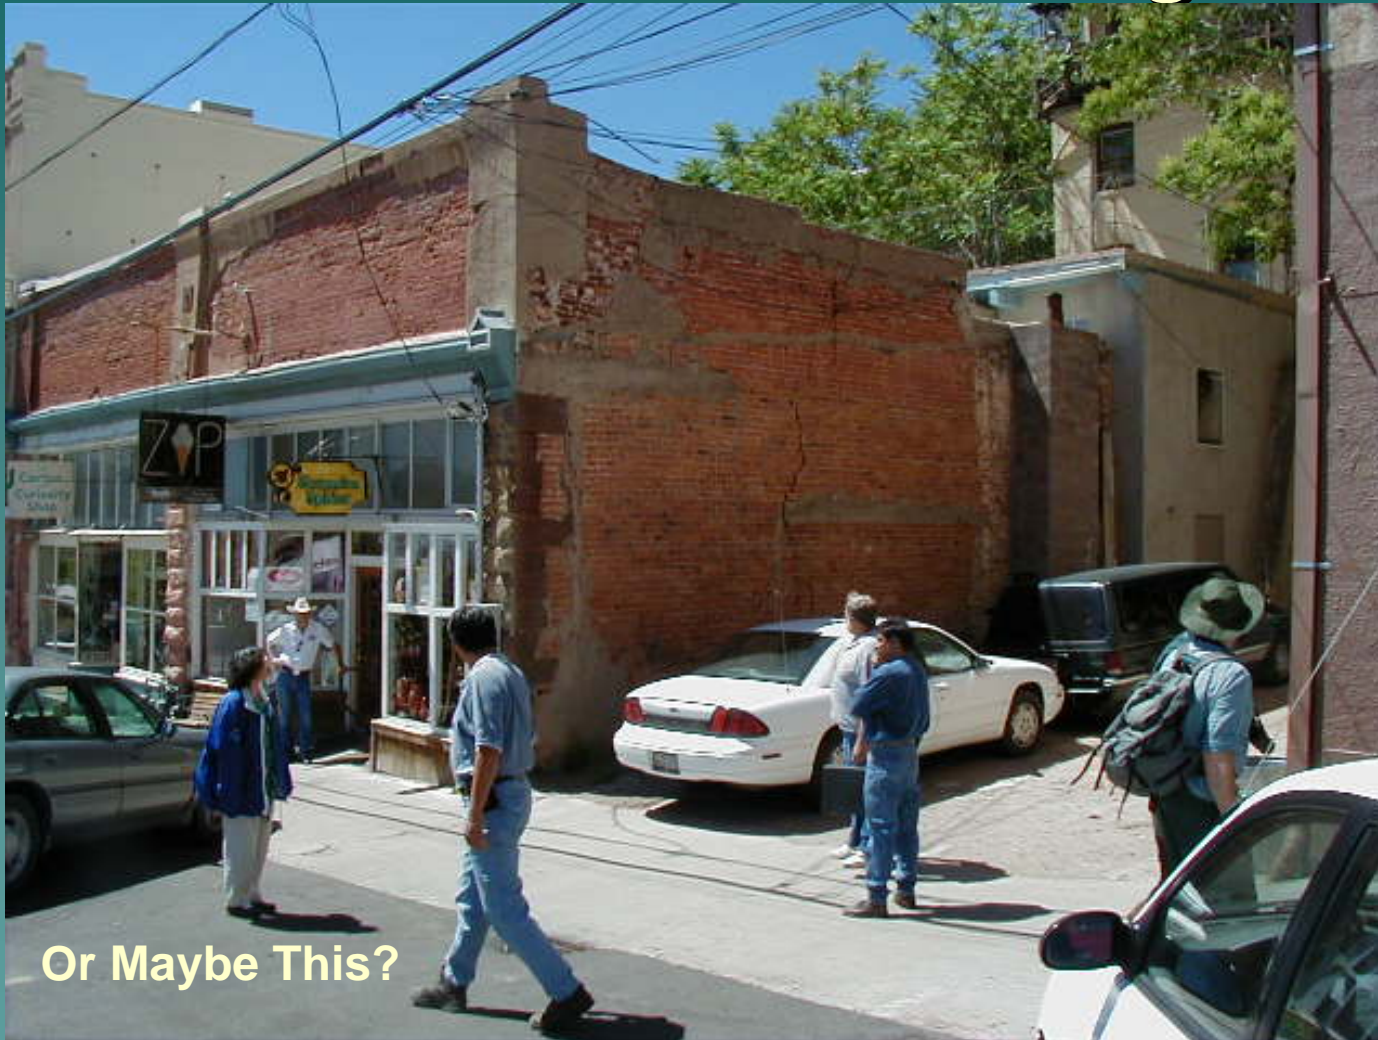
# Cracked Building

Or Maybe This?

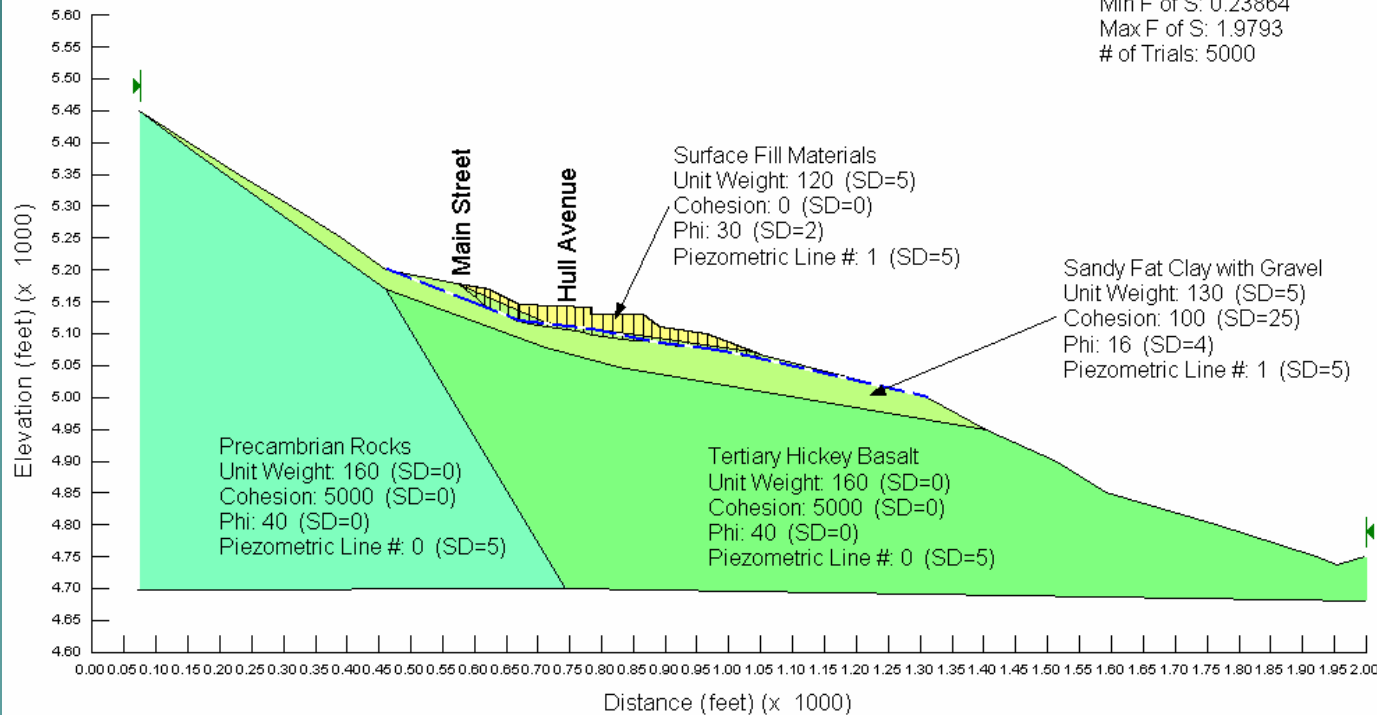
## Proposed Jerome Rest Area Under 2002 Conditions Highway 89A (Hull Avenue) Jerome, Arizona FIGURE 5

Failure Plane Approximately 25 feet bgs.  
Groundwater surface approximately 25 feet bgs.

Factor of Safety: 0.99

Reliability Index: -0.115  
P (Failure) (%): 54.588538  
Standard Dev.: 0.232  
Min F of S: 0.23864  
Max F of S: 1.9793  
# of Trials: 5000
